## 10th INTERNATIONAL CONFERENCE

# MARITIME TECHNOLOGIES

## Tanning Plants on the Island of Samos and the Role of the Sea

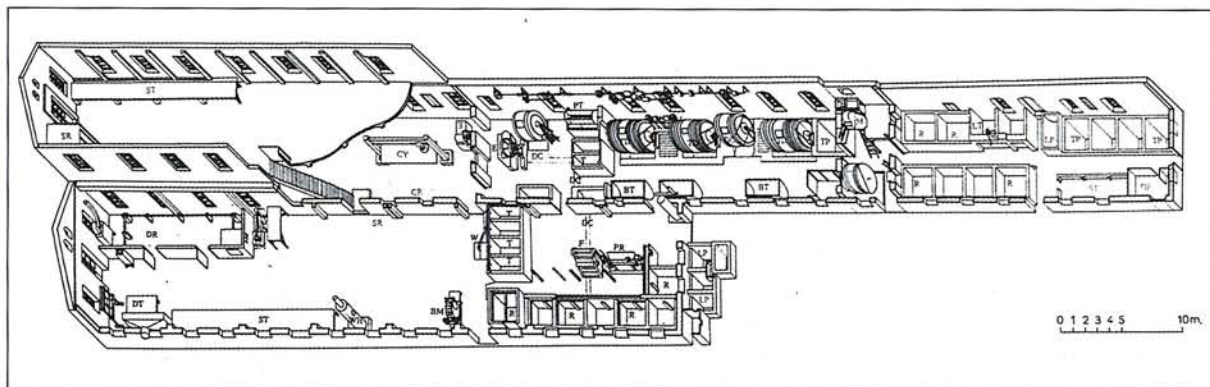
2. Axonometric sectional diagram of D. Talabekos tannery.

M: Bark grinding mill, BM: Buffing machine, CR: Changing room, DT: Dying table, CY: Cylinder, DC: Drainage channel, DR: Drying room, F: Fleshing machine, BT: Half barrel tank, WB: Hot water boiler, I: Iron, LP: Lime pit, P: Mechanic Press, SM: Staking machine, SR: Storage, TD: Tanning drum, TP: Tanning pit, T: Tank (*liba*), OC: Oiling-cleaning drum, OF: Office, E: Oil engine, PT: Paddle tank, RA: Rapid, R: Rockets, ST: Scouring table, LT: Tanning liquor preparation pit, WH: Water heater, W: Well.

Tanning required a large quantity of water during all stages of the process. The proximity with the sea facilitated the discharge of the tanning liquors. Inside the tannery there are channels which convey the waste liquors from the tanks and the drums to a main channel, either outside or inside the building (figure 2). The tanneries which were on the sea front released the waste liquors directly to the sea. For the tanneries located near the west stream, liquors were let to the sea from a main channel that hold the discharged tanning liquors from all the tanneries of the area.

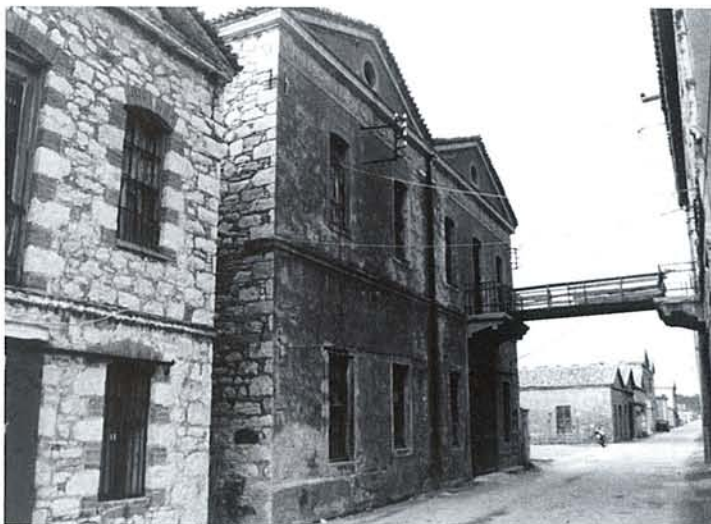
3. Tanneries on the east side of Karlovasi.

Today there are two distinct areas of tanneries; the one is near the Karlovasitiko stream and the other is on the east side of the bay (fig. 3, 4).

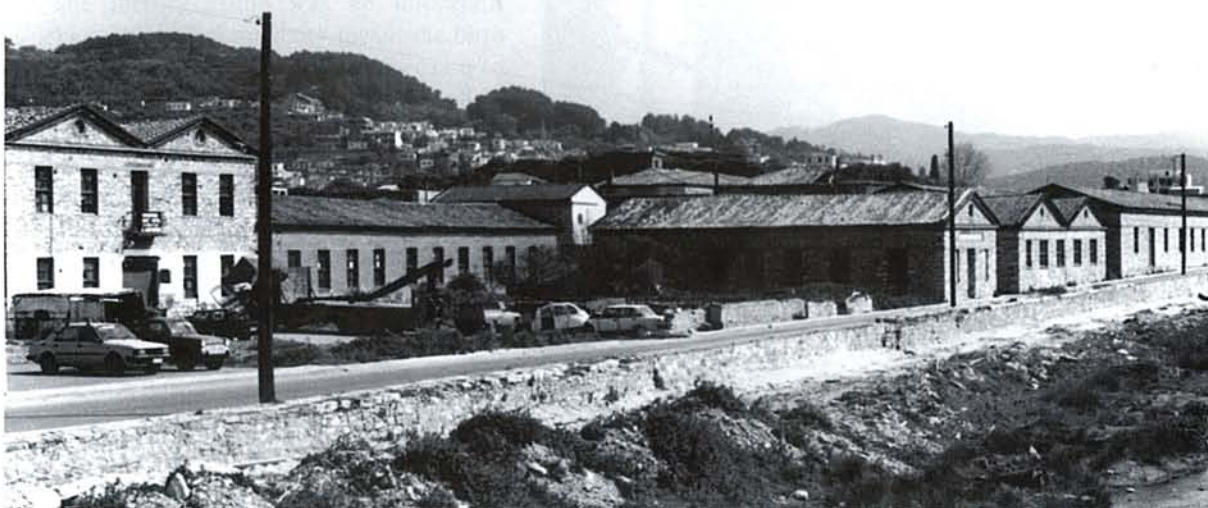
4. Tanneries by the Karlovasitiko (west) stream).
